St Mary's Owatonna School expansion

Completion February 2011
Project Value of \$2.5M
Preschool Rooms, Kitchen upgrades, Bathroom accessibility and
Building security and safety, Parking & Playground upgrades.
Sustainable Underground Stormwater and Raingarden Management System,
Energy Efficient Window Replacement.

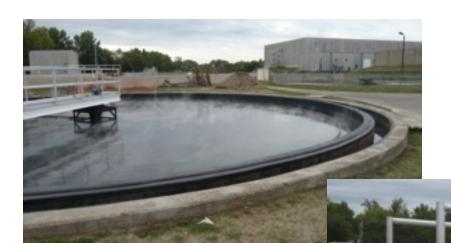
Austin Waste Treatment Clarifier Tank Upgrades 2011

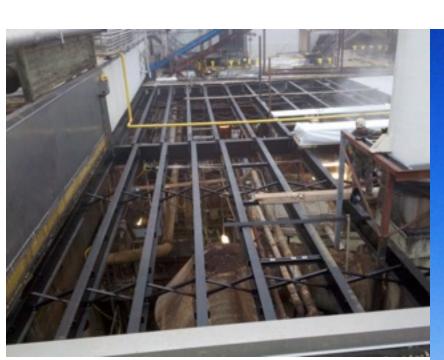
Structural Modifications 350 ton crane -230' reach over a 43' wal 2011

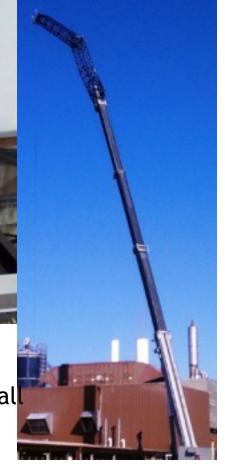
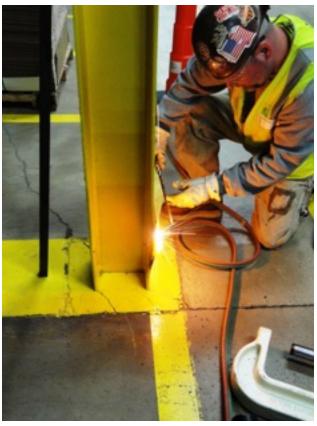
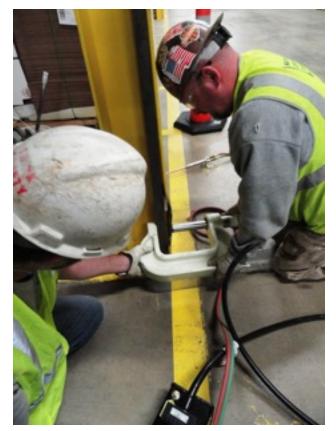
These photos show a couple examples of before and the results after using the heat straightening techniques.

We applied heat using a rose bud, monitored the temperature as per the structural design and bent the steel back into shape. This method can be accomplished with minimum interruptions to plant operations
